EMERGENCY AIRWORTHINESS DIRECTIVE

DATE: April 15, 2003
AD #: 2003-08-51

Send to all U.S. owners and operators of MD Helicopters, Inc. Model 369A, D, E, H, HE, HM, HS, F, and FF helicopters.

2003-08-51 MD HELICOPTERS, INC.: Docket No 2003-SW-17-AD.

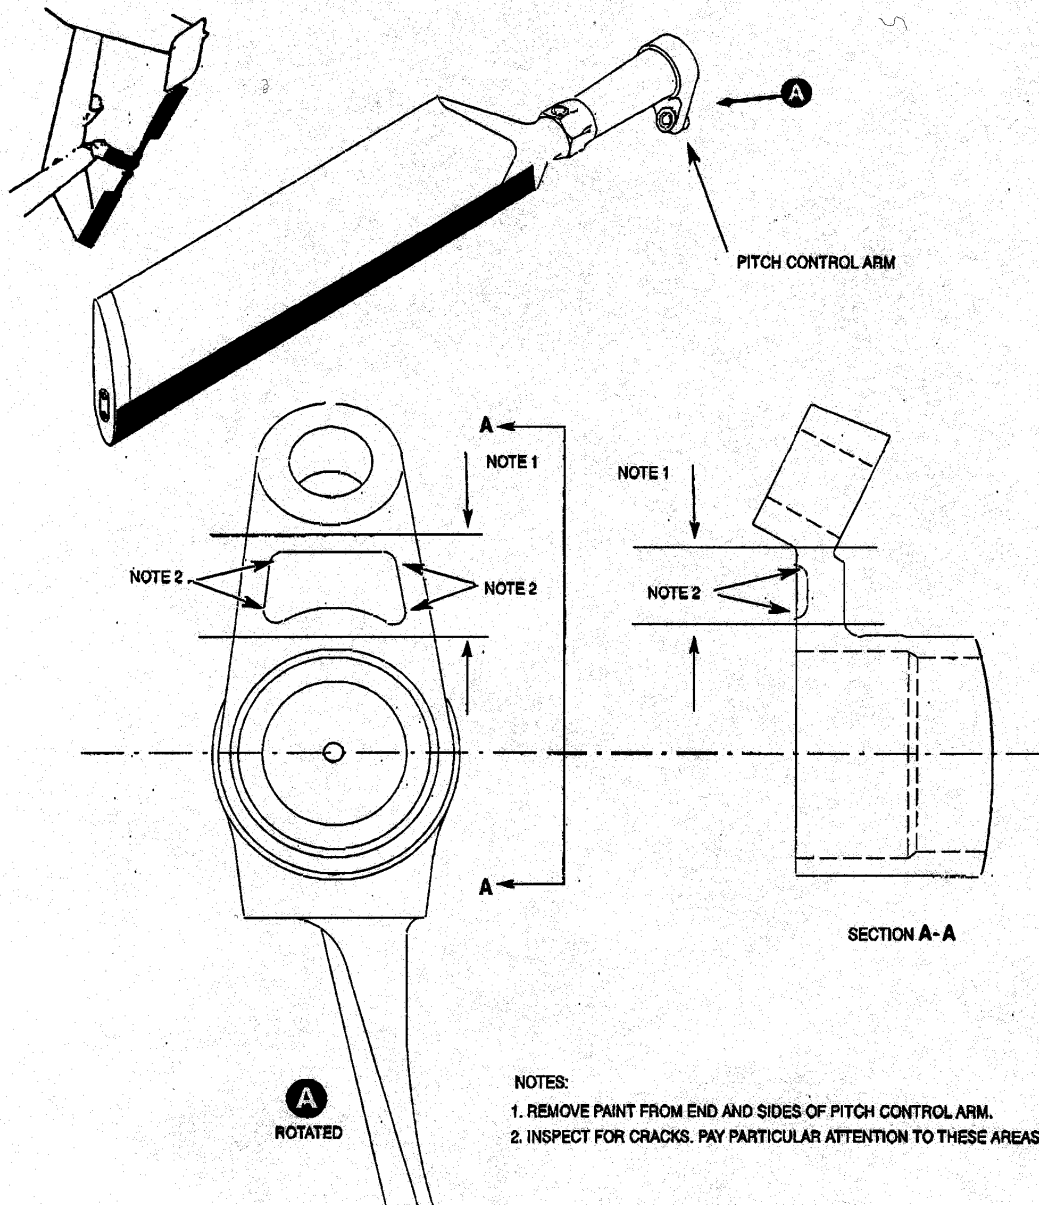
Figure 1. Tail Rotor Blade Assembly Inspection

This Emergency Airworthiness Directive (EAD) is prompted by two reports of cracked tail rotor blade pitch horns (pitch horns) that failed during flight. In both occurrences, the pilot was able to land the helicopter without further incident. Investigation revealed that the cause of the failures was a fatigue crack in the pitch horns that developed before the tail rotor blade reached its retirement life. This condition, if not corrected, could result in a pitch horn separating from the tail rotor blade leading to an unbalanced condition, vibration, loss of tail rotor pitch control, and loss of directional control of the helicopter.

(b) Before further flight, perform a one-time visual inspection of each pitch horn for a crack or corrosion in the area indicated by Note 2 in Figure 1 of this AD. Paint removal in accordance with Note 1 of Figure 1 of this AD is not required for the visual inspection.

(a) This AD establishes a new retirement life of 400 hours time-in-service (TIS) for the tail rotor blades listed in the Applicability section. For helicopters with an affected tail rotor blade installed that has 390 through 700 hours TIS, remove and replace the tail rotor blade with an airworthy tail rotor blade within 10 hours TIS.

(d) For helicopters with a tail rotor blade installed that has more than 700 hours TIS, a one-time special flight permit to fly it to a repair facility may be issued only upon completion of an eddy current surface scan of each affected pitch horn (see Figure 1 of this AD). Paint removal in accordance with Note 1 of the Figure 1 of this AD **IS** required for the surface scan. If a crack is found, remove the tail rotor blade and replace it with an airworthy tail rotor blade before further flight.
